# HVAC and VOC Forensic Analysis

Unit 806 · 315 N 12th Street  
Goldtex Apartments · Philadelphia PA 19107  
Greystar Real Estate Partners (property manager)

<b>Document date:</b>	Sunday, May 17, 2026 (evening)
<b>Period covered:</b>	Nov 22, 2025 → May 17, 2026 (4,235 readings)
<b>Event window:</b>	May 12 → May 20, 2026 (5 days actual + 3 forecast)
<b>Prepared by:</b>	Justin Horn (Thumper)
<b>Primary sensor:</b>	Sonoff SNZB-02 (Zigbee → eWeLink cloud, hourly)
<b>Cross-validation:</b>	Apple HomePod (Apple HomeKit)
<b>Unit status:</b>	Vacant since May 6, 2026 (VOC displacement)
<b>Audiences:</b>	L&I · civil counsel · PCHR · council · medical · family

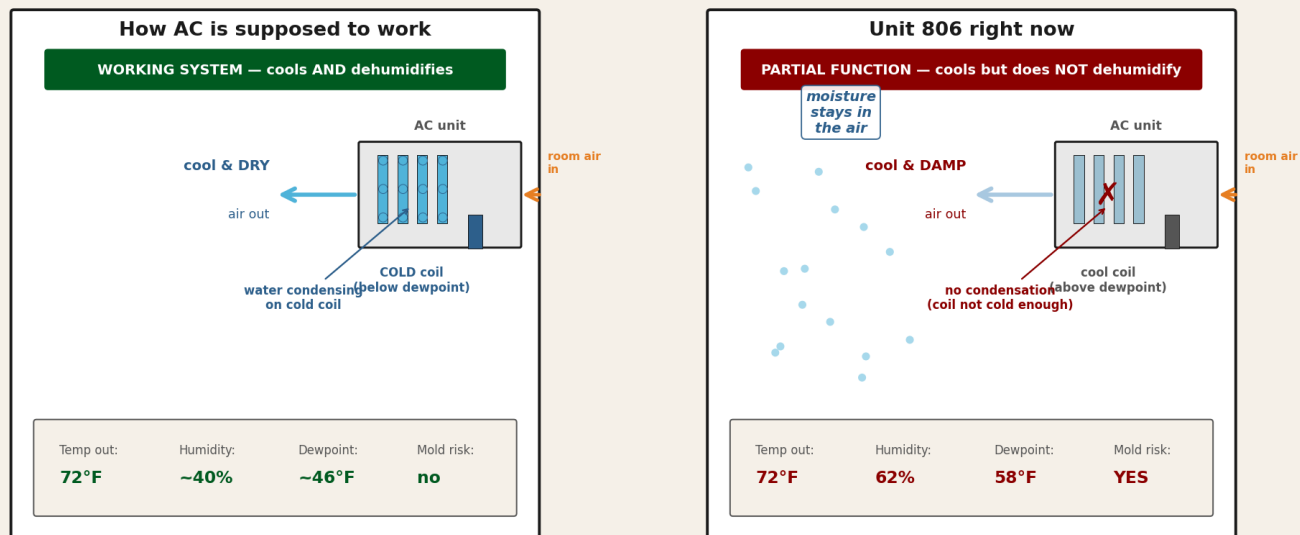
Figure 1. Why temperature dropped while humidity rose

A working AC pulls moisture out of the air by condensing it on a cold coil. In Unit 806, the coil is no longer cold enough to condense water — so the air gets cooler but stays just as wet.

Figure 1. A working AC chills its coil below dewpoint, causing water to condense out of the air. Unit 806's system has the coil running, but not cold enough to condense water — so air gets cooler but stays just as wet.

The Sonoff dataset shows indoor dewpoint climbing from 53.3°F (Sun 3 AM, no AC running) to 58.4°F (Sun 9:56 PM, AC running ~12 hours). Dewpoint rose 5°F over the period the AC was active — the opposite of what a

properly functioning system produces. Combined with the temperature drop (indicating refrigerant is present and the compressor is producing some cooling), this is most consistent with explanation (a): refrigerant was added to a system with an underlying leak or coil issue, producing partial cooling without restoring dehumidification.

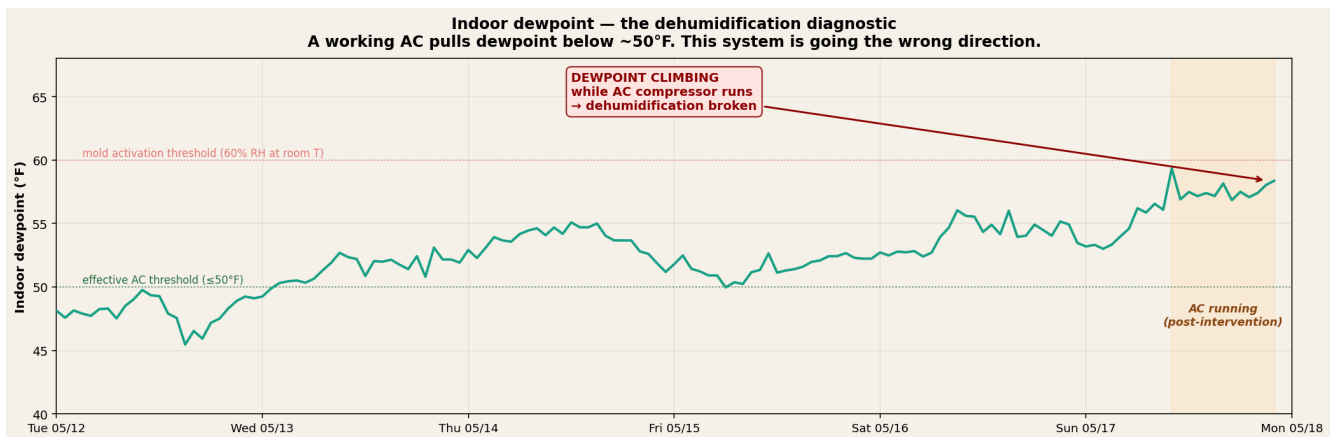
**5.1 Indoor dewpoint trace — the diagnostic**

The cooling appeared. The dehumidification did not. Across the same period where indoor temperature dropped from 80.4°F to 72.1°F, the indoor dewpoint **rose** from 55.5°F to 58.4°F — moving in the wrong direction for a properly functioning AC. This is a critical diagnostic, addressed in Section 5.

Indoor dewpoint from the Sonoff sensor, May 12–17. The green threshold (50°F) is what a working AC would pull air down to. The red threshold (60°F) is sustained mold-activation. Dewpoint crosses INTO the danger zone during AC operation rather than out of it — mechanically impossible for a system with effective dehumidification.

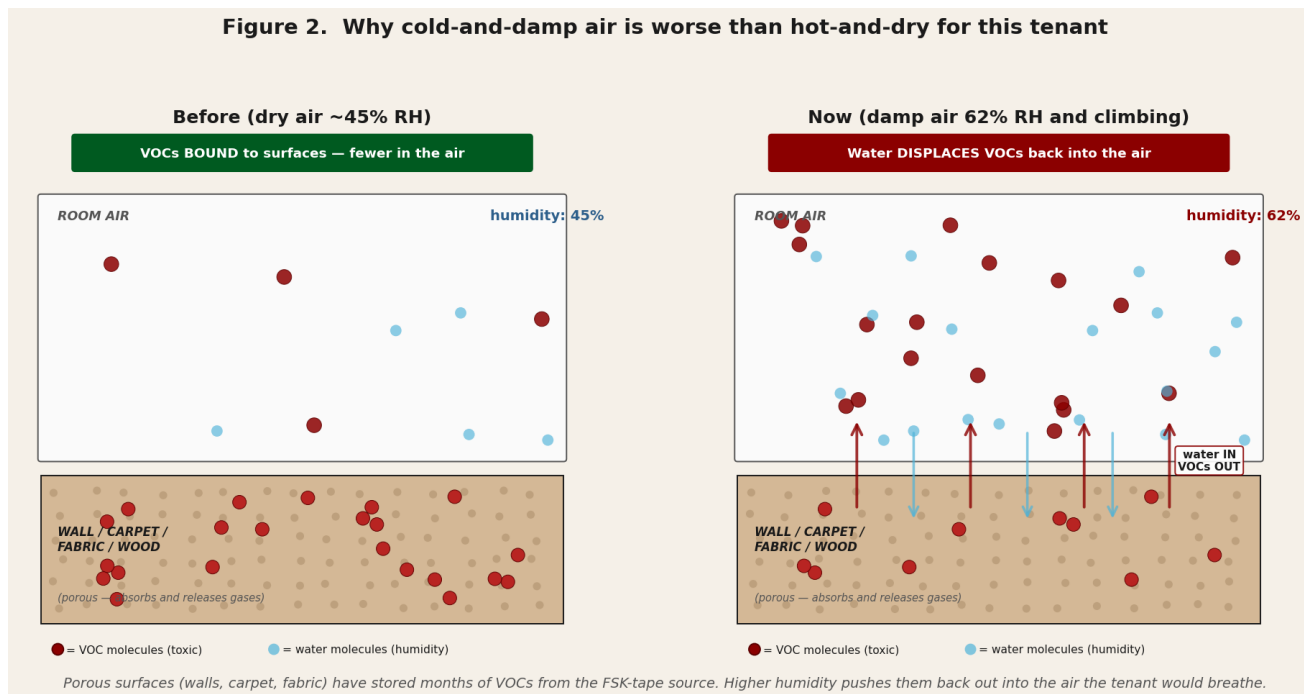
Figure 2. Why cold-and-damp air is worse than hot-and-dry for this tenant

Figure 2. Porous surfaces (walls, carpet, fabric) absorb VOCs over months. Water molecules outcompete VOC molecules for surface binding sites. When humidity rises, VOCs are displaced back into the air the tenant would breathe.

Release rate is governed by competition between water and VOC molecules for surface binding sites. When humidity rises, water displaces previously-bound VOCs back into the air. This is humidity-driven re-emission. The effect is measurable, replicable, and well-established in building science literature.

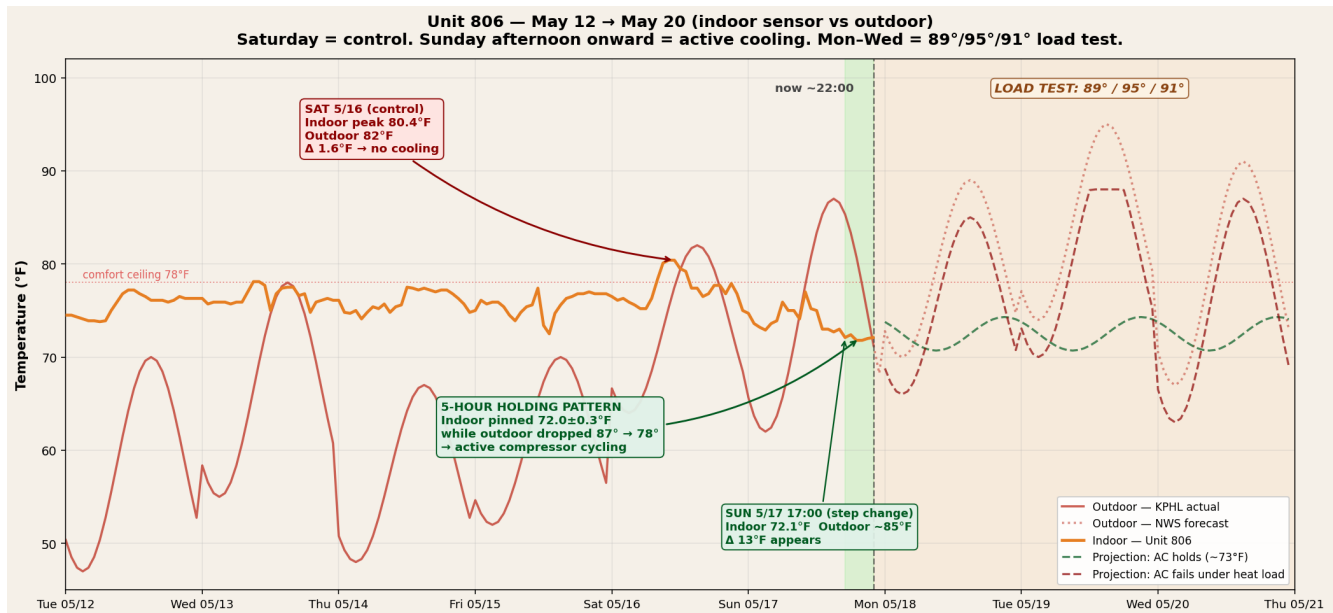
### 7.1 Temperature trace with the 5-hour pinned signature

This 5-hour pinned signature constitutes the strongest evidence yet that the compressor is now actually running — confirming a real intervention occurred. The system is no longer the non-functional one of the prior 5 days. However, as documented in Section 5, the partial restoration is missing the dehumidification half of the cycle.

Indoor temperature (orange) vs outdoor (red), May 12–17 actual with three-day forecast envelope. The green-shaded Sunday-evening band highlights the 5-hour holding pattern where indoor remained at 72°F while outdoor dropped 9°F. Dashed lines show the two Mon–Wed scenarios depending on whether the May 17 fix was real or cosmetic.

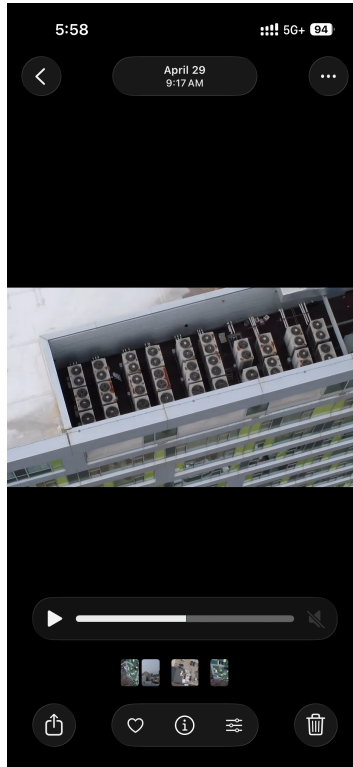
*Drone photograph, April 29, 2026 9:17 AM EDT. Building rooftop mechanical well showing stacked per-unit outdoor condensing units. Visible rust streaks and water staining on multiple cabinets indicate deferred maintenance across the equipment fleet.*
